**Regional Balkans
Infrastructure Study -
Transport**

Appendix 1 - Final Report

Network Assessment

July 2003

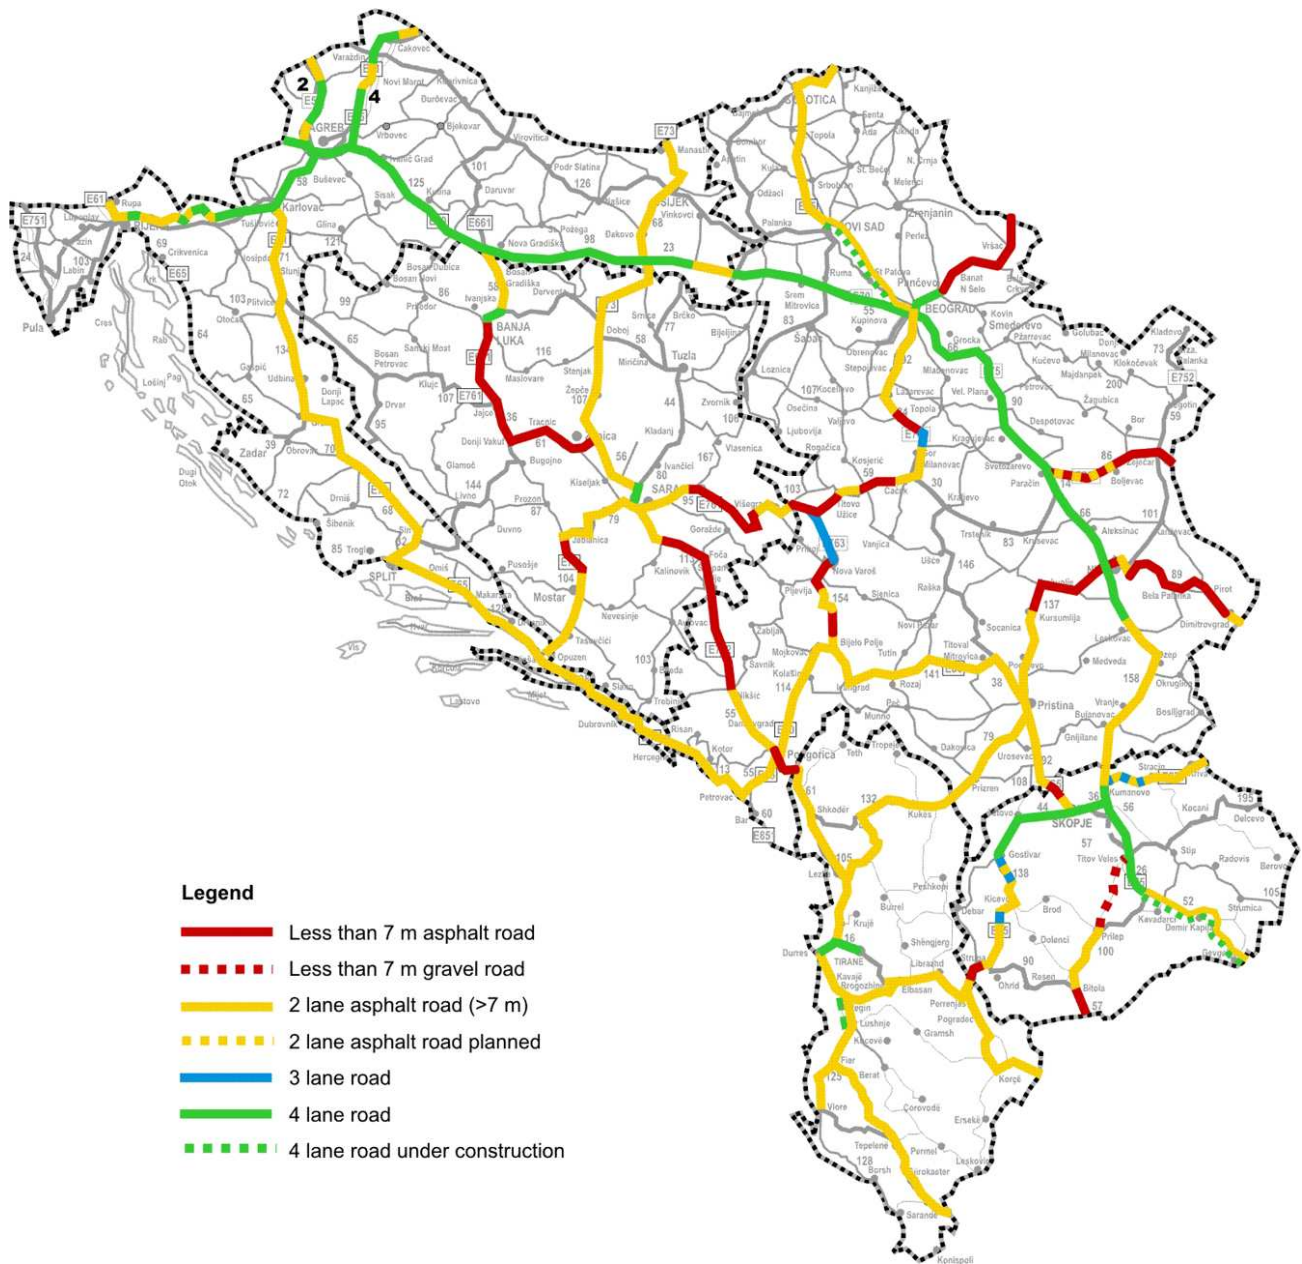
Figure 2.1 Road geometry.

Widening of narrow roads. An important issue is the widening of roads and increasing curve radii. About 870 km or 13 % of the roads need to be upgraded because they are too narrow. They have to be at least 7 m wide in order to fulfil the minimum AGR standard.

Corridor X has 4 lanes on most of its sections, except for the southern part, while other corridors and routes have 2-lane roads. In the central part of the region, bottlenecks of around 870 km of roads need widening or realignment due to insufficient pavement width.

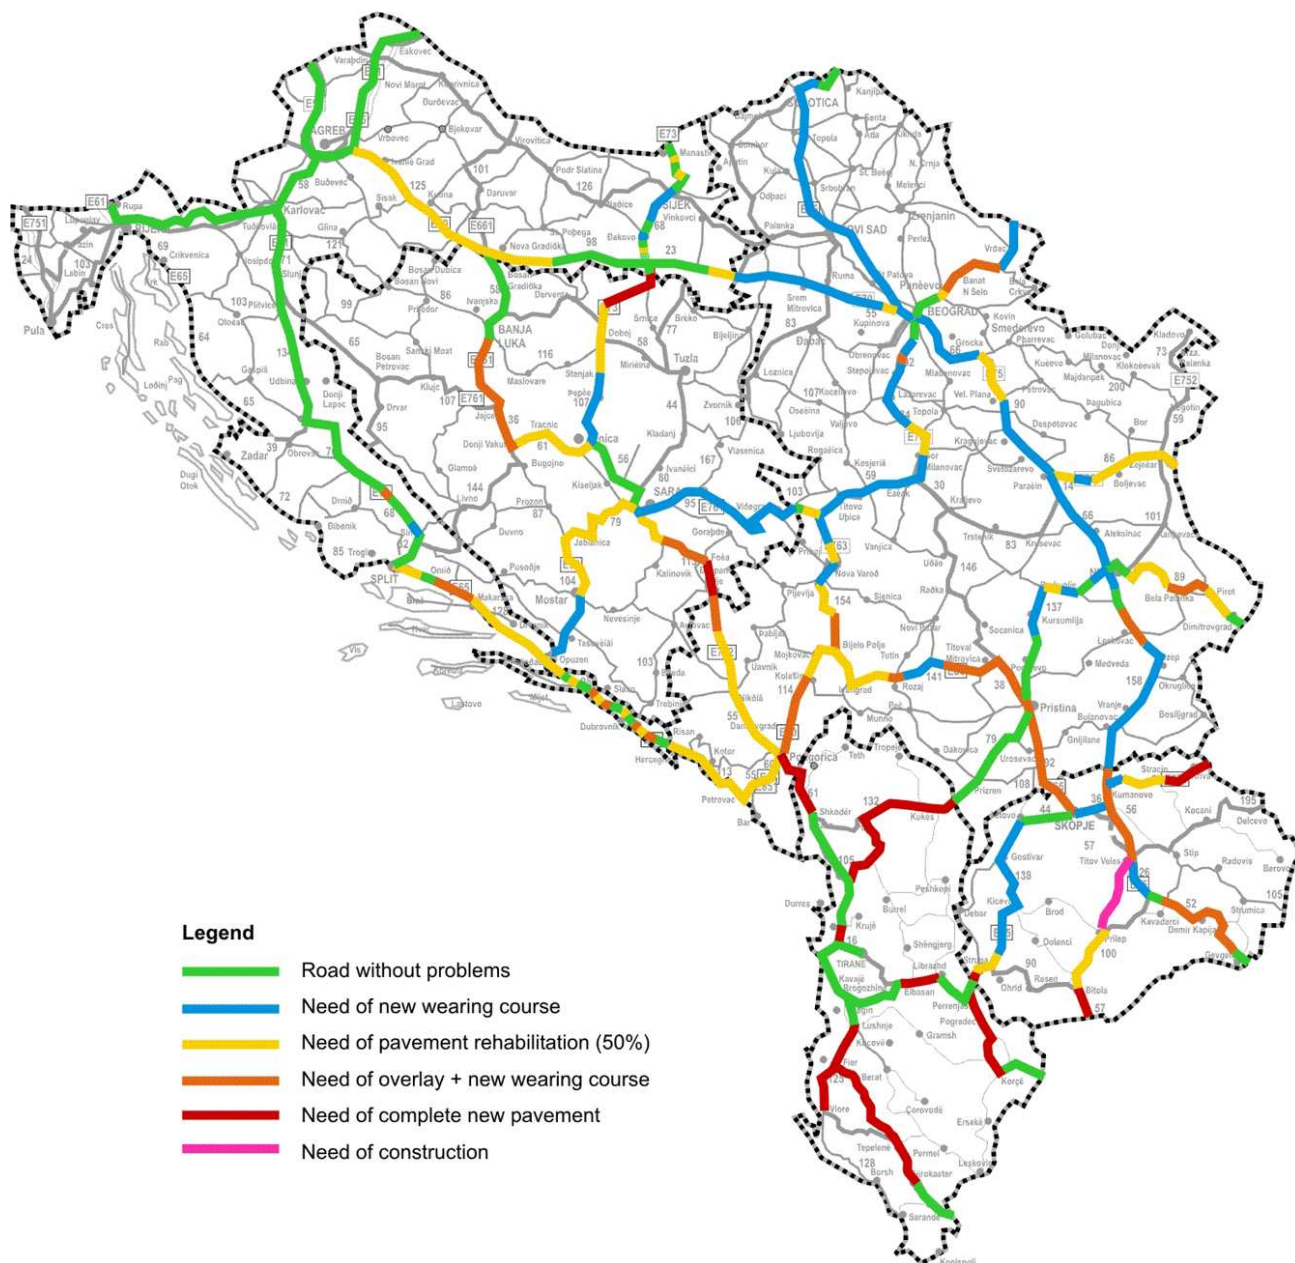
Figure 2.2 Road condition.

Pavement condition. Another main issue is the upgrading of existing pavements for some of the roads. The condition of pavements is:

However, there are major differences from country to country. The best pavement condition is found in Croatia, where the majority of the roads are in good condition. In Albania the roads are either newly rehabilitated or badly in need of complete reconstruction because the traditional pavement is a penetrated Macadam which is not able to resist present and future axle loads.

Corridor X has a reasonably good pavement condition, however, in certain areas, there is a need for a new wearing course and in the southern sections this would have to be combined with an overlay.

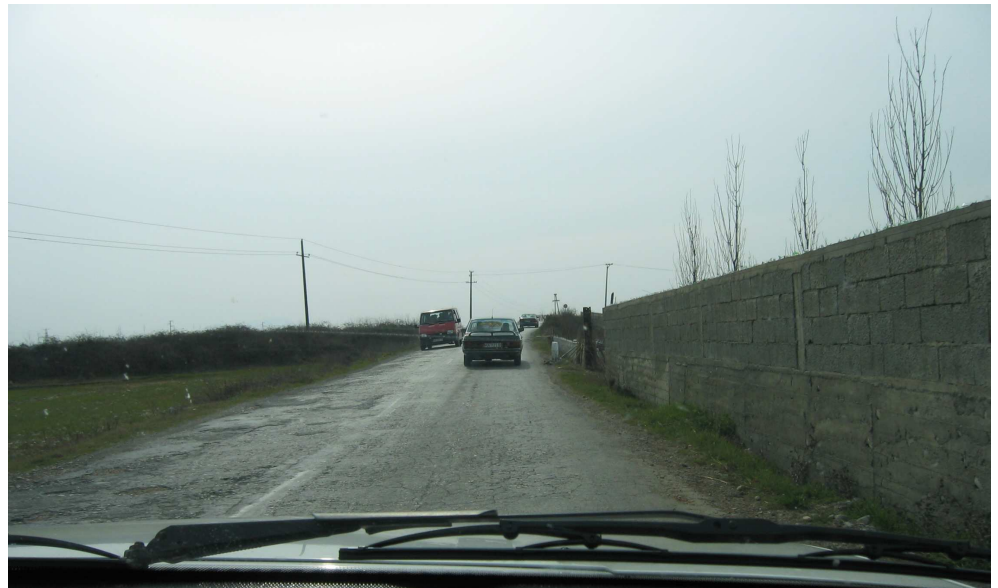
Albania is the country which shows the widest variation in road quality. Until recently the entire road network was in a state of deterioration and in poor condition. A typical pavement consisted of penetrated Macadam with a large number of potholes but the country has, during the past few years, begun constructing new roads and reconstruction of some main roads.

Figure 2.3 Typical road before upgrading.

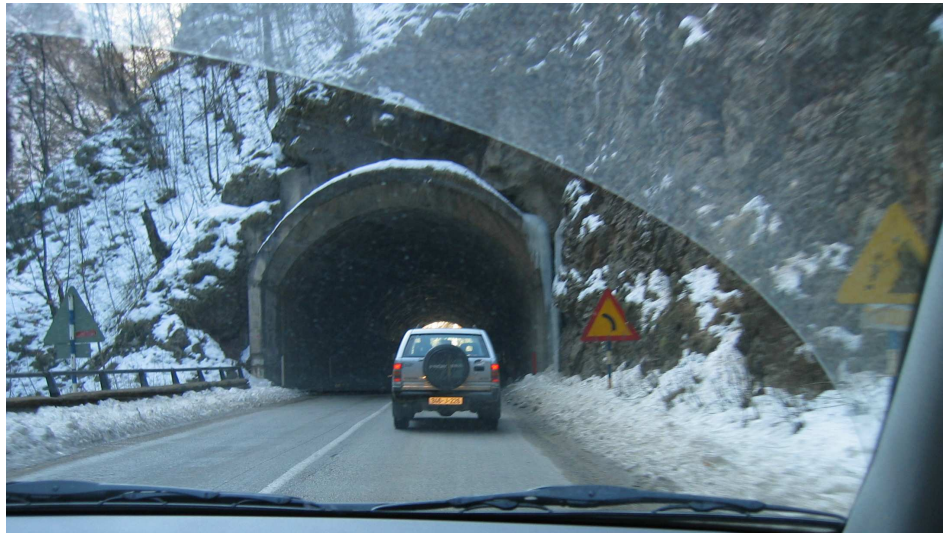
Figure 2.5 There is a need for rehabilitation and maintenance of some roads and tunnels and for protection against landslides.

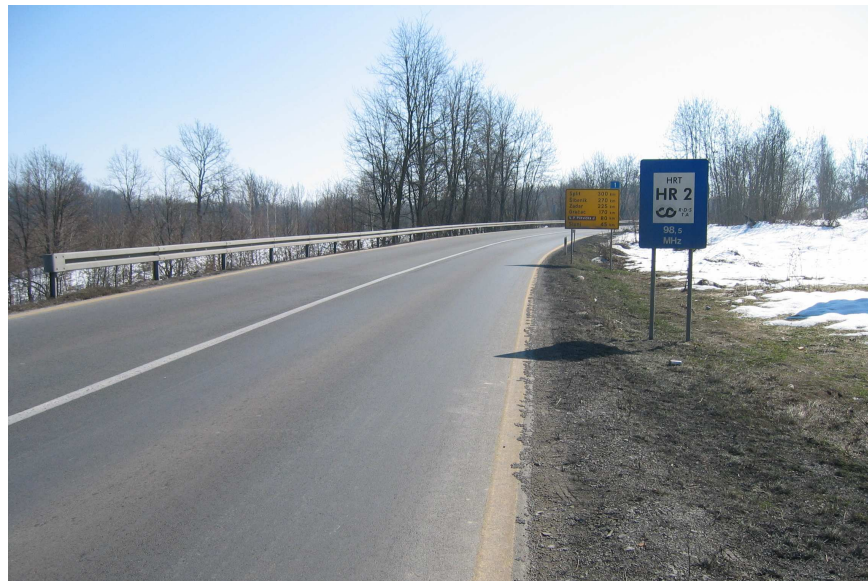
Figure 2.6 Condition of the road network is, in general, very good.

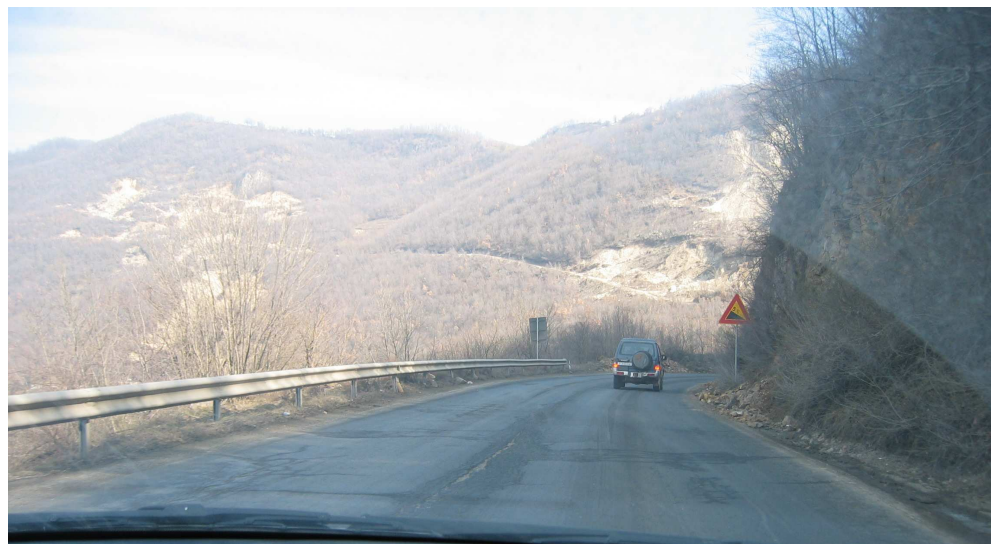
The pavement condition indicates a need for an overlay and new wearing course on almost half of the roads.

Figure 2.10 Road between Gabrica and Den Jankovic.

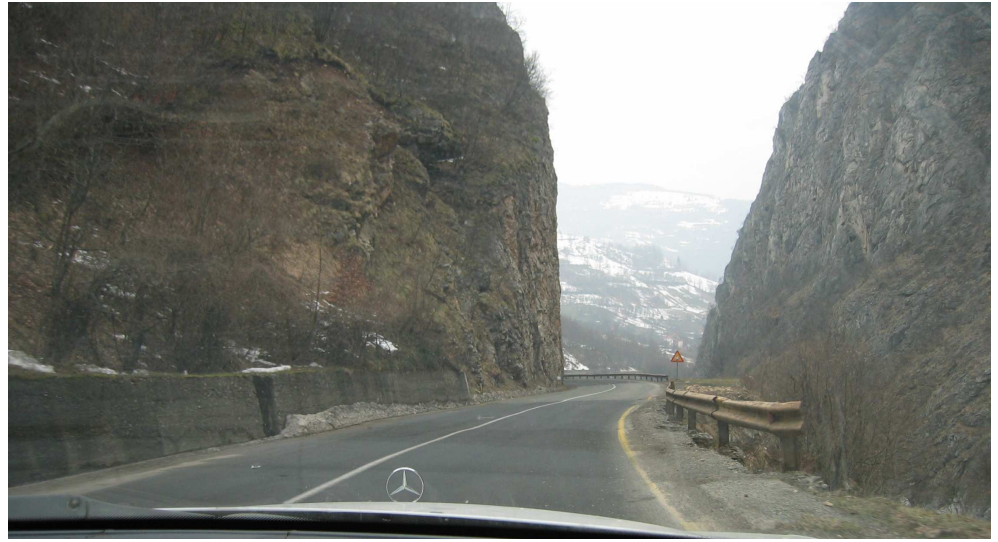
All roads in the core network in Montenegro are 2-lane roads some of which are very narrow.

Figure 2.11 Montenegro needs climbing lanes and protection against landslides.

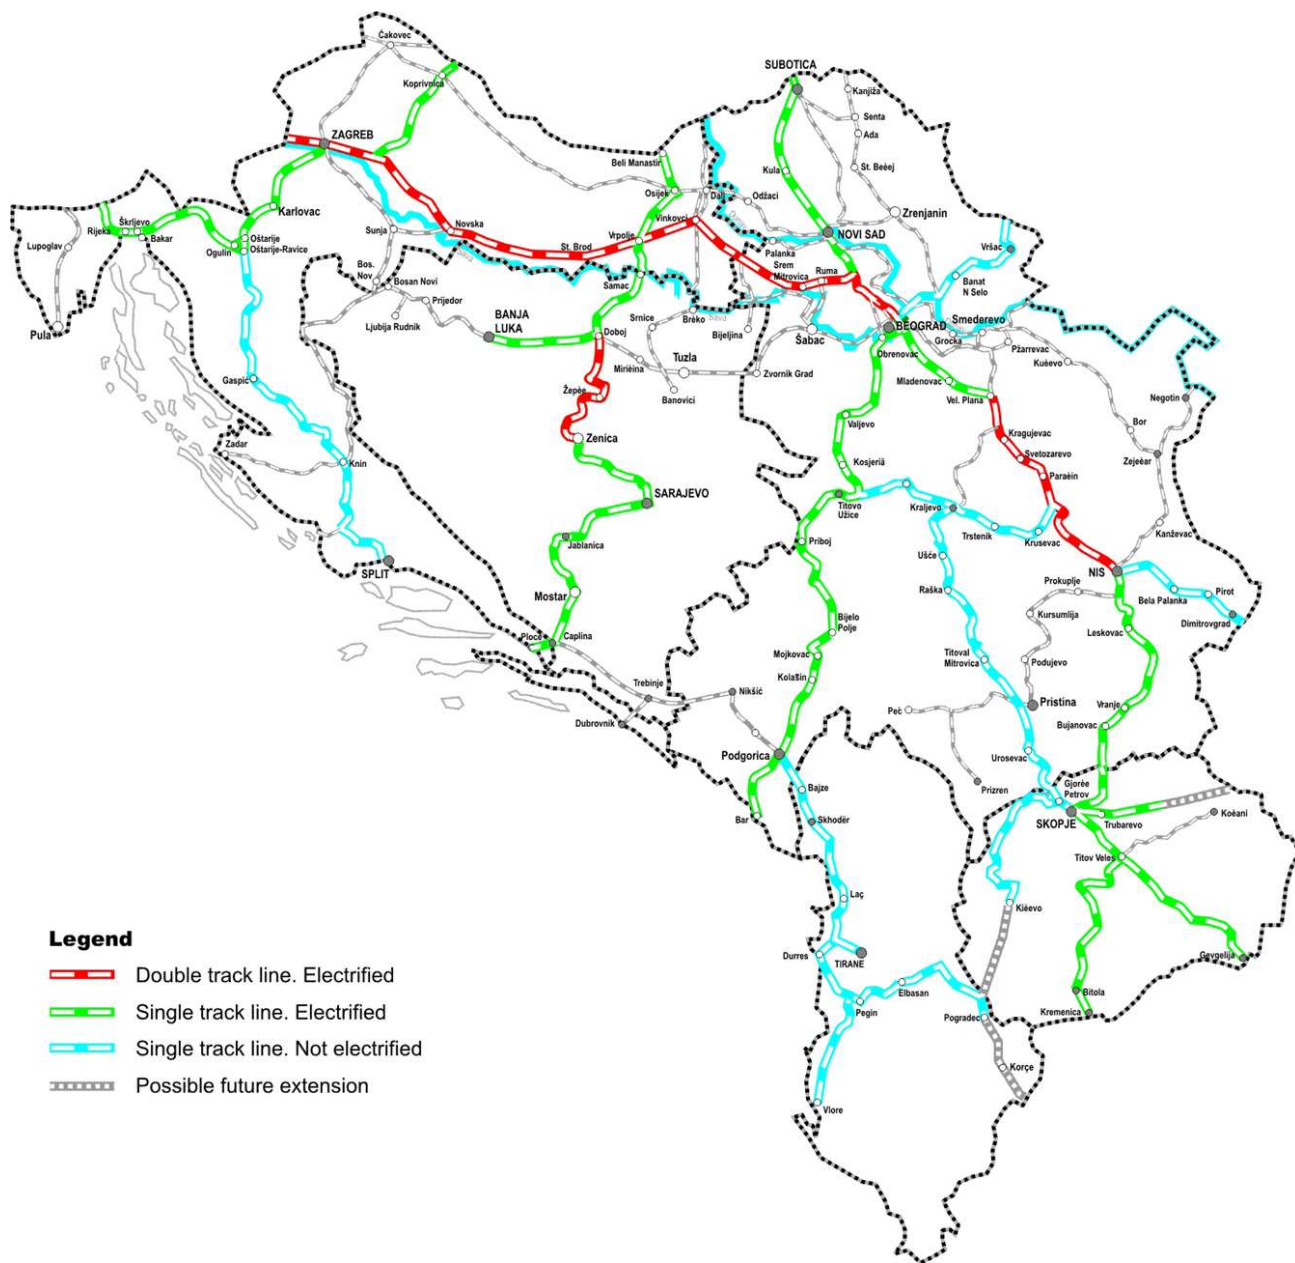
Annex 1.1 Map no. T01: Present technical condition

The present technical standard and condition varies over the network. The main differences in technical standard are shown on the map "Present Technical Condition" in Annex 1.1, and in the schedule "Present Technical Condition Details" inserted in Annex 1.2.

- 86% of the network has single track
- 59% of the network is electrified
- only 11% of the network is classified as being in good condition while the remaining sections are in medium or bad condition
